DSTO-TR-0480

F-111C Lower Wing Skin Bonded  
Composite Repair Substantiation  
Testing

R. Boykett and K. Walker

**Airframes and Engines Division  
Aeronautical and Maritime Research Laboratory**

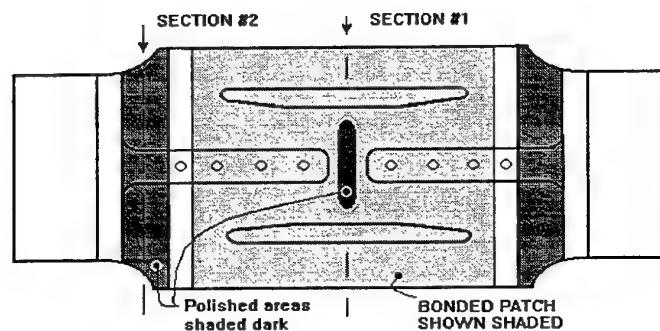
Figure 5. Panel specimen.  
View onto side representing upper surface of lower wing skin.  
Boron \ Epoxy patch is bonded to side representing lower surface.

Several test specimens failed outside the test area. Two panel specimens failed under static loading in the tapered region close to the grips of the testing machine<sup>14</sup>. These were attributed to stress concentrations due to the changes in geometry. Referring to Figure 5, the cross-sectional area at section 2 (less than 828.6 mm<sup>2</sup>) is smaller than that at section 1 (829.2 mm<sup>2</sup>), when there is no crack. Also, a repaired panel specimen (patched and cracked) may be weaker outside the patch, without some treatment of the area in section 2. Later panel specimens were then polished and shot-peened in the area of section 2 to prevent this type of failure.

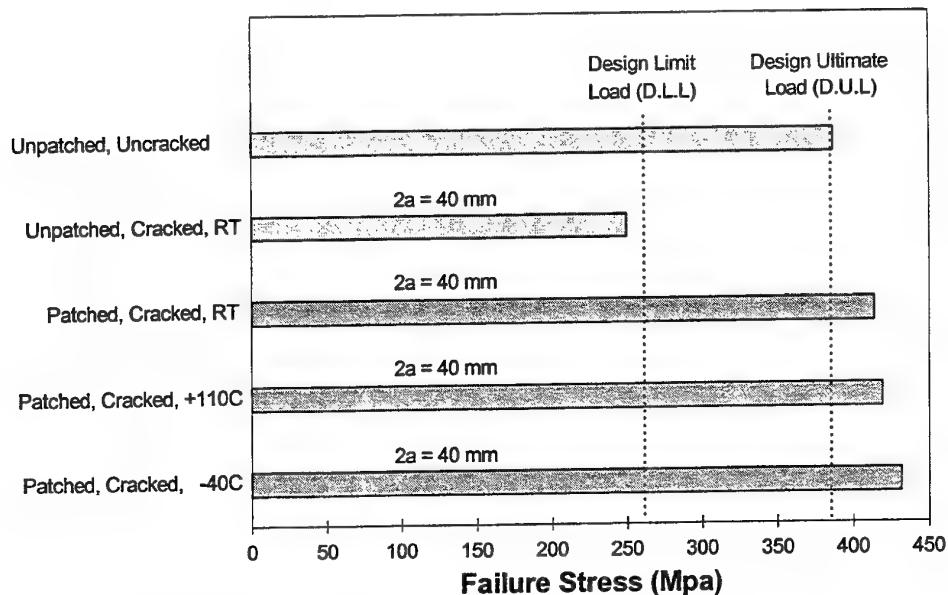
Figure 6. Results of static strength tests on panel specimens.

- 1) The undamaged "baseline" panel fails at DUL but the unrepaired damaged panel does not meet DLL. This was predicted by fracture mechanics calculations<sup>1</sup>.

- 2) The repaired panels all exceed DUL, with little effect noted between the different temperatures. The temperature gradient on the specimen during the hot test (+110°C) ranged from 83.0°C to 119.4°C, and during the cold test (-40°C) from -16.3°C to -42.2°C. The maximum values were at the centre of the specimen due to heat transfer from the ends of the specimen into the grips of the testing machine<sup>14</sup>. However, the hot test was repeated at later date (August 1996) using a new environmental chamber. The specimen *FLTP-17* had already been used for fatigue loading (50,000 simulated flight hours and the crack had grown to 69.4 mm). The temperature range on the specimen was 105°C to 112°C, within the boundary of the boron patch, when it failed by the crack propagating to the edges at a load of 204.7 kN (247 Mpa). Since the Design Ultimate Stress for the high temperature load case<sup>7</sup> is 214.5 Mpa, the specimen *FLTP-17* demonstrated that the repair restores static strength above DUL at high temperature. This is considered to be a remarkable achievement for the FM73 adhesive because 110°C is well above the glass transition temperature,  $T_g$ .

- 3) The "baseline" specimen and the first hot test specimen both failed outside the test section.

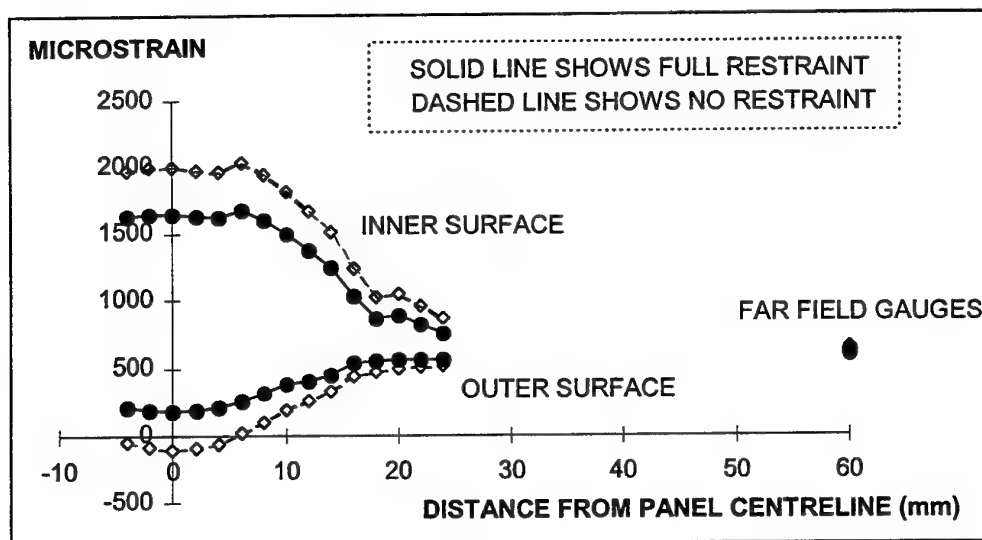
Figure 7. Chordwise strain distribution at 20% DLL (after CPLT case)

Note that the high strain variation reduces to within 25% of the nominal (far-field) value within 20 mm of the panel centreline (representing the spanwise spar line). The crack in RAAF aircraft A8-145 was 48 mm tip-to-tip (symmetrical about the spar line).

Note also that the peak strain on the inner surface at 20% DLL is approximately 1600 microstrain. Assuming a linear relationship with loading, this equates to approximately 8000 microstrain at 100% DLL, which is well in excess of the uni-axial yield strain for the material of 5500 microstrain. Even allowing for some degree of non-linearity, this result indicates that significant yielding can be expected in the area

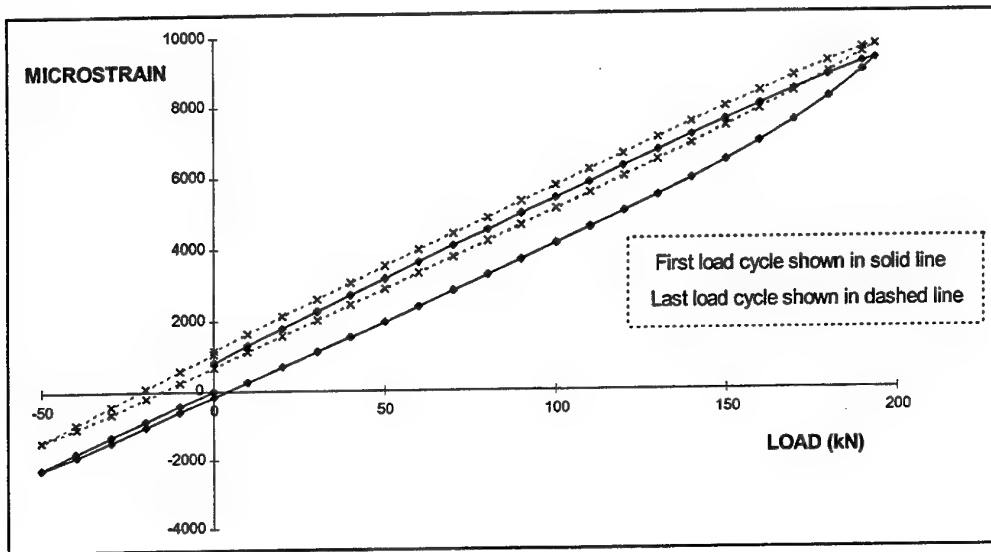
Figure 8. Panel specimen during CPLT load case (strain gauge SO5A-3 at centreline on side representing upper surface of lower wing skin).

Note that there is non-linear deformation in this area (where the cracking initiates) when first loaded above 70% DLL (149 kN). This effect is followed by hysteresis and residual tensile strain of 1100 microstrain.

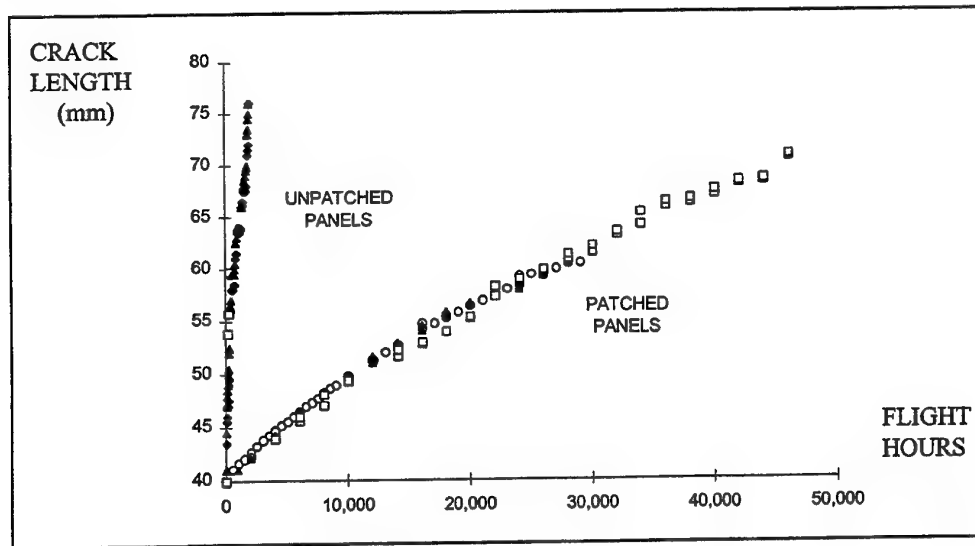
One patched specimen (FLTP27-12) had several static strength tests applied after it had endured 30,000 equivalent flight hours (including CPLT cases). At crack lengths between 62 and 63 mm, the DUL (318 kN) was applied nine times with no failure. Then, when the crack was grown to 134 mm (under constant amplitude cycling), the ambient static residual strength was found to be 310.2 kN (97% DUL).

Figure 9. Fatigue crack growth rates using the cycle-by-cycle spectrum

These results indicate a significant improvement in life obtained from the patch repair. 30,000 flight hours approximates 100 years at current RAAF usage rates.

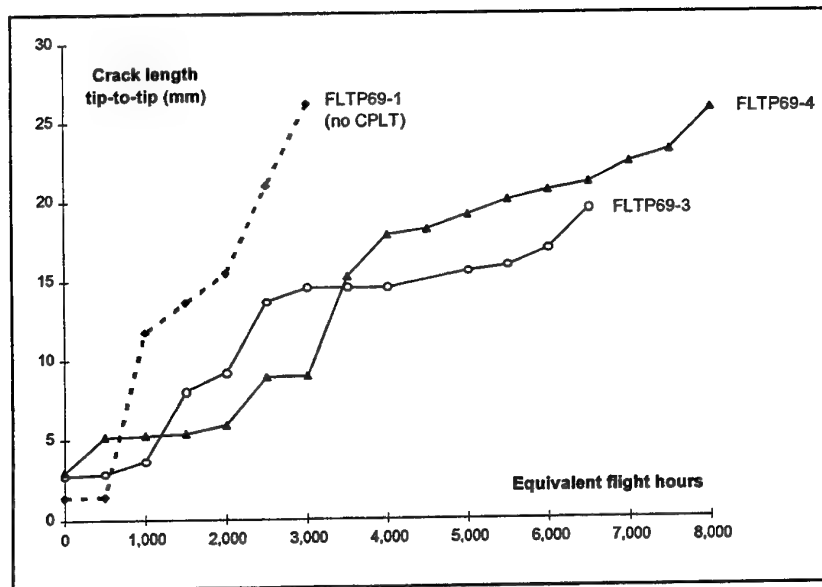
From Figure 10, the average crack growth curve gives a growth time from  $2a = 6 \text{ mm}$  to  $2a = 20 \text{ mm}$  of approximately 2,000 hours. These results therefore support an inspection interval for this region of approximately 1,000 hours.

Figure 10. Crack growth of panel specimens from first initiation under the cycle-by-cycle loading spectrum.

Note that the specimen FLTP69-1 was not loaded quite the same as the others; the CPLT load cases were omitted until the last block (whereupon it failed).

Using the above data, an estimate of the time to grow from the minimum measurable size (6 mm) to the critical crack length (20.6 mm) ranges from 1800 to 5500 equivalent flight hours.

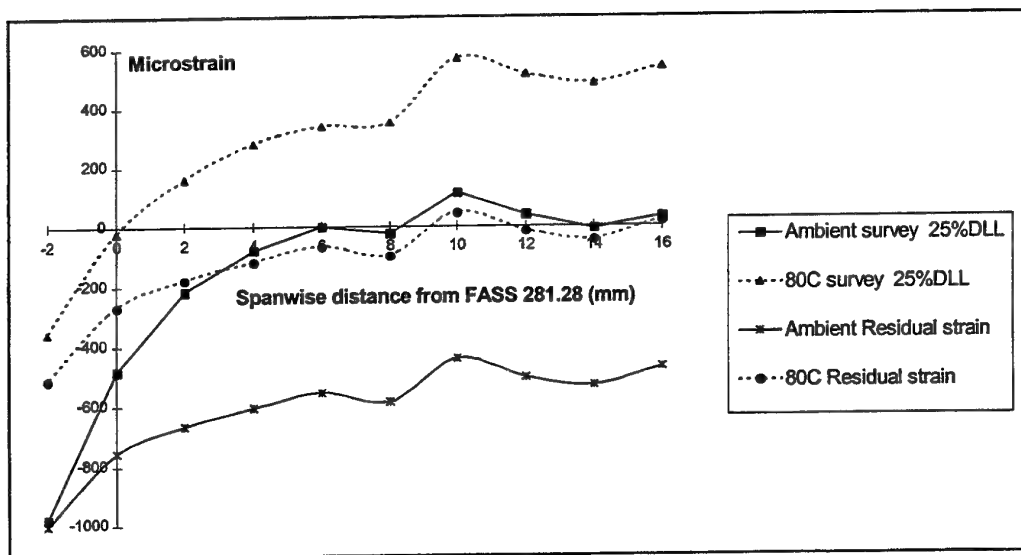
Figure 11. Strain distribution in the boron patch at 25% D.L.L. on panel specimen *FLTP69-4*.

The strain distributions, shown above, include all residual strain from the patch cure and the temperature effect on the strain gauges at 80°C. The values of residual strain are shown for reference. The residual strain at ambient temperature was measured with the specimen fully assembled, but resting on a flat surface; the residual strain at 80°C is calculated relative to those ambient values with an offset correction, given from Figure 12.

The total strain in the centre of the patch at 80°C is clearly much higher (by approximately 500 microstrain) than that at ambient temperature under the same loading conditions. However, when allowing for the effects of residual strain and temperature, the net strain distribution at 25% DLL (ie compared to zero load) is very similar in both cases (23°C and 80°C).

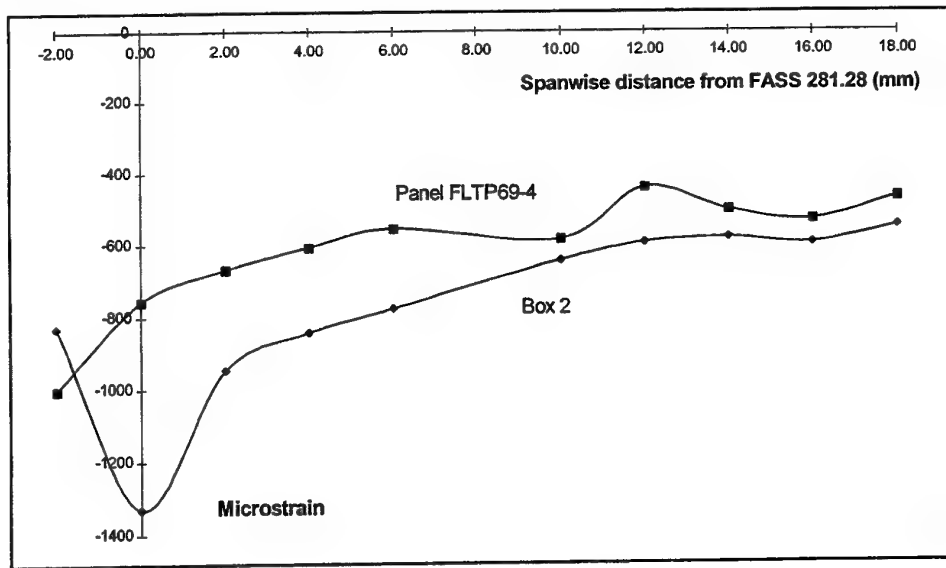
Figure 13. Residual strain distribution at zero load, ambient temperature

The residual thermal strain distribution in the boron patch is similar for both box and panel types of specimens. The residual strain in the aluminium structure would be expected to be a similar level but tensile. This significant level of residual tensile strain in the local region of the crack could be expected to have the effect of increasing the stress ratio,  $R$ .

The residual strain in the boron patch on the panel specimen was not at its maximum at the centre; this can be partly explained by the accidental 0.5 mm offset of the patch from the centreline and also because the pre-crack in the panel did not initiate on the centreline, but approximately 2 mm from it. The residual strain at the centre of the boron patch is greater in the second box specimen<sup>24</sup> (Box 2) than in the panel specimen (FLTP69-4).

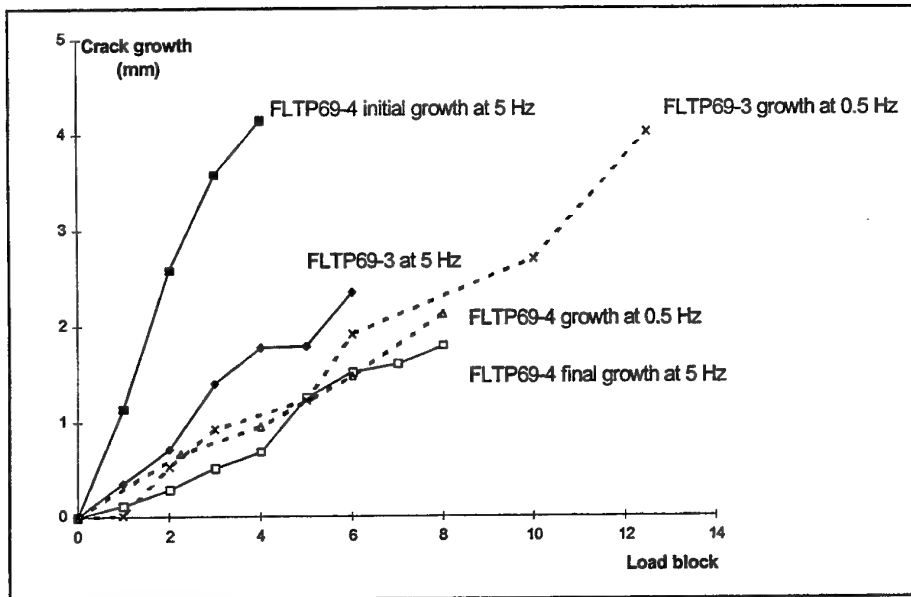
Figure 14. Crack growth comparisons at ambient temperature in specimens FLTP69-3 and FLTP69-4.

Slope of ambient growth at 5.0 Hz = 0.24, 0.39 and 1.08 mm per block (500 hrs)

Slope of ambient growth at 0.5 Hz = 0.31 and 0.26 mm per block (500 hrs)

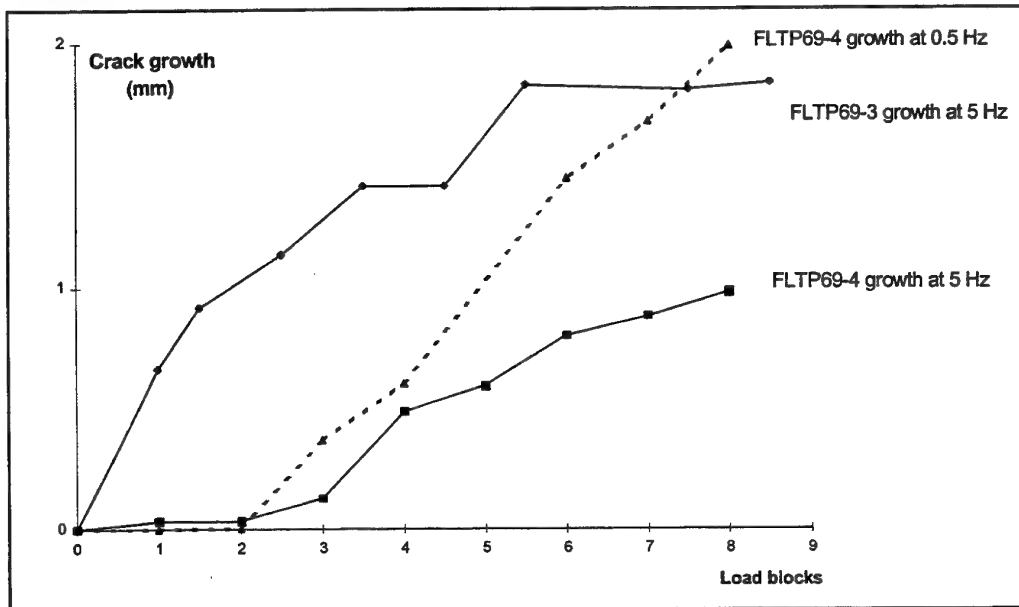
Figure 15. Crack growth comparisons at 80 °C in specimens FLTP69-3 and FLTP69-4

Slope of 80°C crack growth at 5.0 Hz = 0.14 and 0.19 mm per block (500 hrs)  
 Slope of 80°C crack growth at 0.5 Hz = 0.28 mm per block (500 hrs)

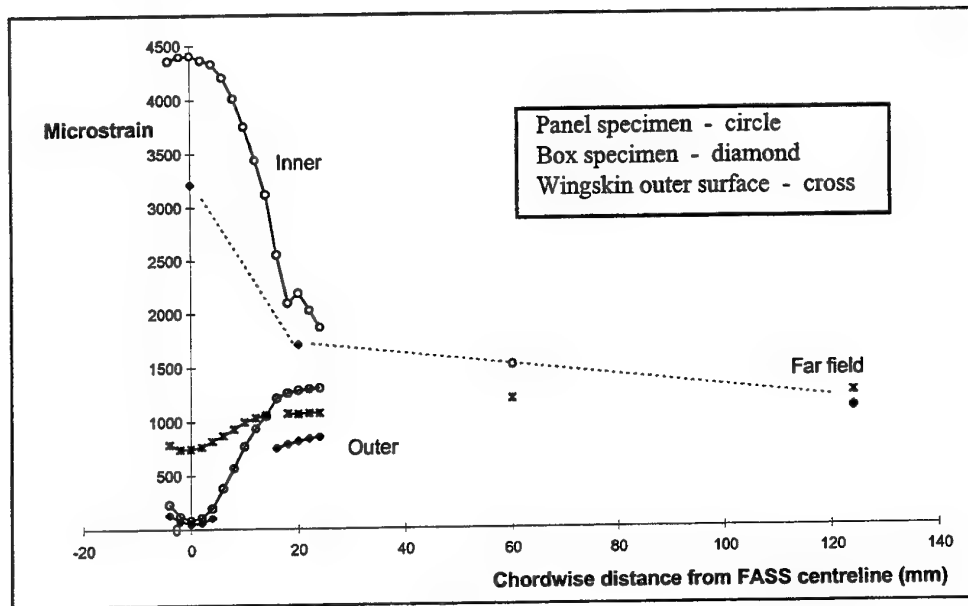
Figure 17. Strain distribution chordwise at 50% D.L.L.

The far field strains are similar in the box specimen (1100  $\mu\epsilon$ ) and the full sized wingskin (1150  $\mu\epsilon$ ) but both are lower than in the panel specimen (1500  $\mu\epsilon$ ). A similar difference is evident for the strain on the side representing the inner surface of the wing skin at the centreline, (3200 $\mu\epsilon$  for the box specimen and 4400 $\mu\epsilon$  for the panel specimen). The distribution of strain across both specimens is consistent, but both specimen types show considerably more secondary bending than the full scale wing. This is partly because the specimens were manufactured to the design skin thickness ( $3.7 \pm 0.1$  mm) compared with the test wing, which is 4.2 mm thick in this area. It is also partly due to the fact that the bending restraint in the panel specimen is not identical to the full-scale wing.

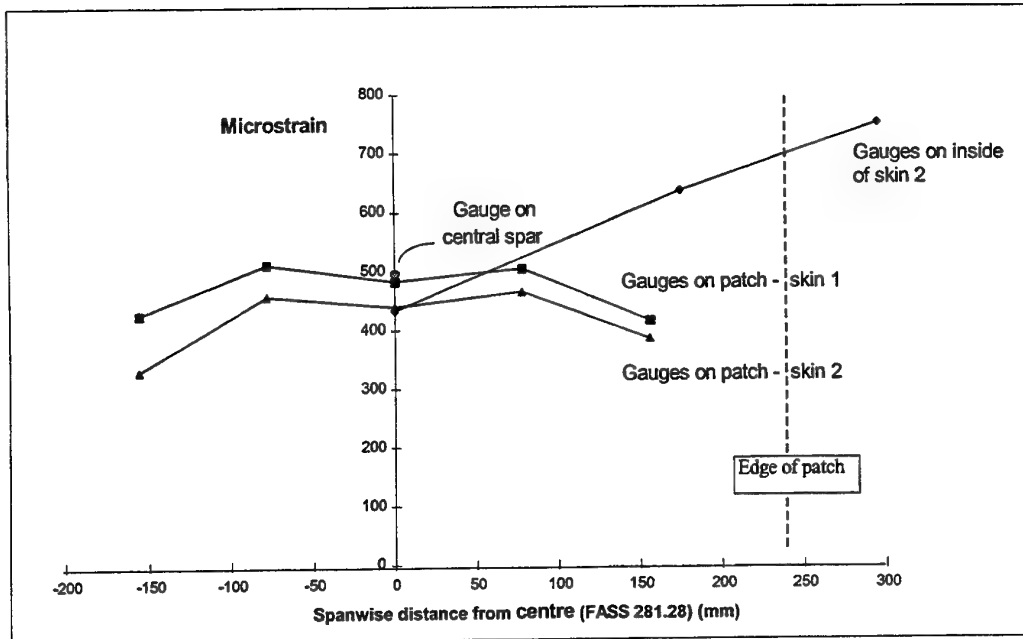
Figure 18. Strain distribution at 20% D.L.L. of fully assembled box specimen prior to fatigue spectrum loading.  
Refer to Appendix 4 for strain gauge labelling and locations.

At the centre of the specimen, the strain in the patch, the skin panel and the central spar/web are within 10%, indicating that the load is evenly distributed between the three elements. Most of the load transfer from the aluminium skins into the boron patch has occurred within 90 mm from end of the patch. There is no evidence of load transfer within 70 mm of either side of the crack at the centre (FASS 281.28).

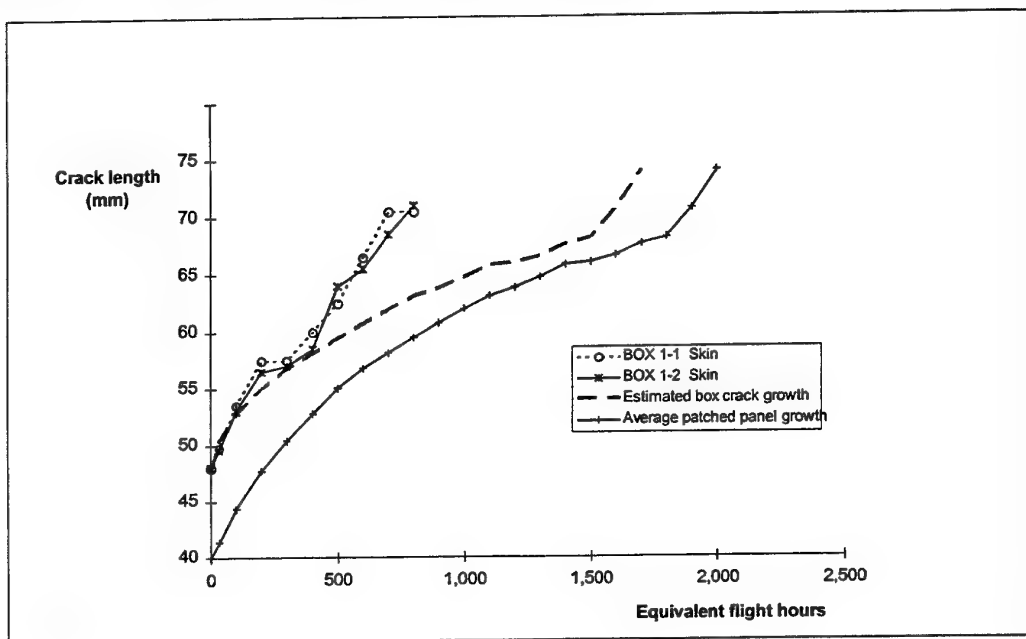
After 800 equivalent flight hours of the blocked loading spectrum, the crack length in each skin was 70.5 and 71 mm. Ultrasonic A-scan NDI carried out in the vicinity of the crack gave "indications" of disbonding for a spanwise distance of about 6 mm and about 70 mm in the chordwise direction. However, subsequent teardown inspections were not conclusive as to whether such a disbond really existed or not. The stress analysis carried out for this repair<sup>9,25</sup> indicates that plastic deformation is expected in the adhesive in the region of the crack. It also indicates that if a disbond was to occur, then the local stresses and strains would be relieved and the disbond would not propagate. The test results are consistent with this analysis.

Figure 19. Specimen crack growth under blocked spectrum loading.

The patched and pre-cracked panel specimens were tested from 40 mm crack lengths (compared to 48 mm in the box specimen), so an equivalent predicted crack growth curve for the box specimen is calculated by translating (horizontally) the average growth curve to match the values at 48 mm to obtain the dashed curve shown in Figure 19, above.

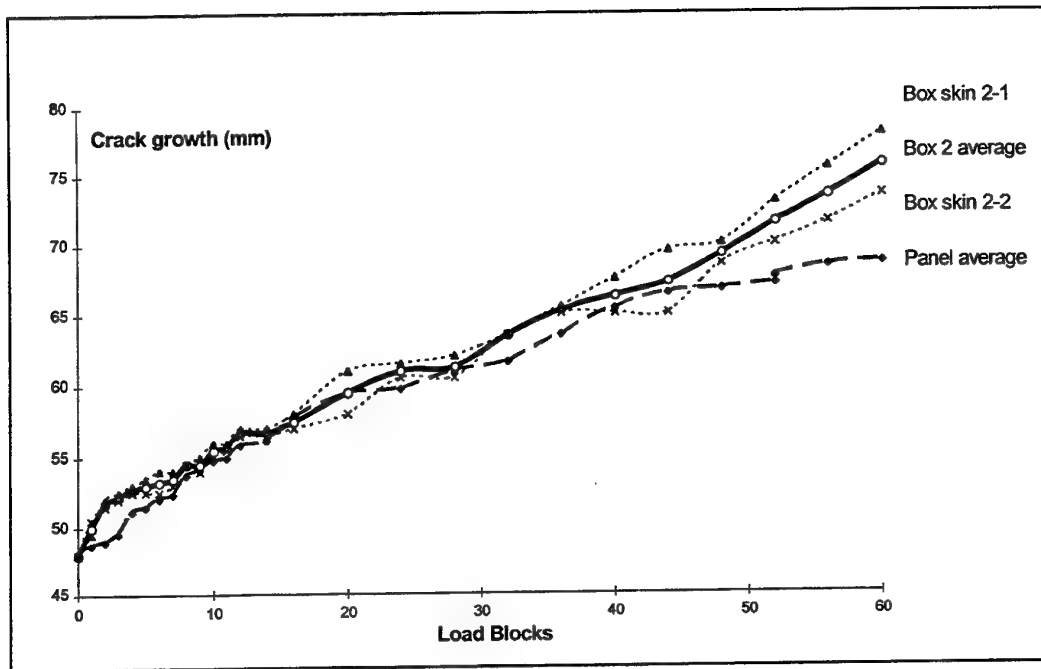
The specimen was then statically loaded to failure in tension. Two fasteners, connecting the end fittings to the tongue adaptors, failed during this test before both skins fractured at the fastener line just beyond the end of the boron patch at a load of 91.4% D.U.L. After disassembly, it was discovered that four other bolts had failed from fatigue cracks during the cyclic testing. Fretting was severe between the steel fittings and aluminium spars/skins and most fastener holes in the spars were elongated. Two

of the end fittings were severely distorted locally under the tension bolt head by the static loading.

Figure 20. Second Box Specimen post-repair crack growth

The patched and pre-cracked panel specimens were tested with crack lengths starting from 40 mm (compared to 48 mm in the box specimen), so an estimated crack growth curve for the box specimen was calculated as per Figure 9.
